echanics, when you pull the powerpack in your M88A1 recovery vehicle for scheduled services, pay special attention to the engine mounting bracket, NSN 5340-00-752-7607.

Crewmen, when it's time to check the engine belts on your M113A3 carrier, don't forget the one for the generator.

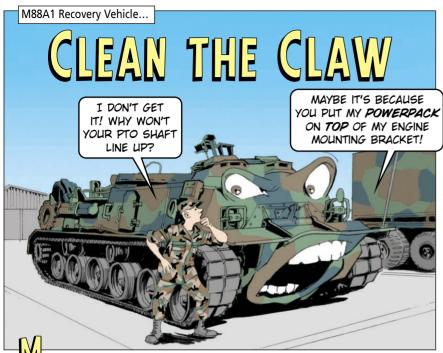
The bracket is a claw-like device that holds the bottom of the powerpack and attaches it to the hull.

Problem is, dirt and oil from the bottom of the engine compartment collects on the mount and keeps it from opening or closing completely.

You don't want that to happen when you try to reinstall the powerpack. The powerpack won't lock down because it's sitting on top of a mounting bracket that's still partially closed, and the PTO shaft won't line up. That means the transmission won't engage and you're going nowhere fast.

And don't even think about trying to open the mounting bracket with the power-pack in place. That just breaks the \$400 bracket. Plus, you'll still have to pull the powerpack again to replace the bracket.

So save yourself a lot of time, money and aggravation the next time you pull the powerpack. Clean the engine mounting bracket thoroughly. Use a nylon brush to clean off heavy dirt and oil. Then use the engine mount release to make sure the bracket opens and closes completely before reinstalling the powerpack.

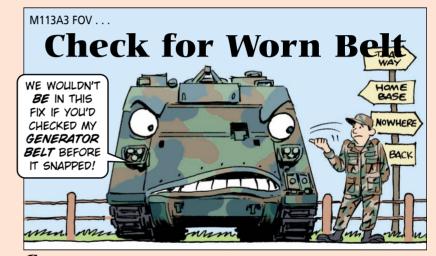
Sure, removing the bottom access panel is a hassle. But if you don't remove it, you can't get a good look at the generator belt.

A worn belt will snap during operation and you'll lose power as soon as the batteries run down.

Take a close look at the pulleys, too. Nicked or bent pulleys will make a good belt go bad quickly.
